## **ANNUAL REPORT FOR 2007**

Michael's Branch Mitigation Site Alamance County TIP No. U-3110A

Prepared By:
Natural Environment Unit & Roadside Environmental Unit
North Carolina Department of Transportation
August 2007

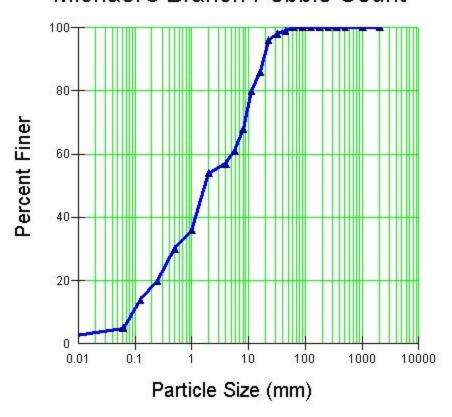
## Michael's Branch Pebble Count

The Year 2007 representative pebble count for Michael's Branch indicated a  $D_{50}$  of approximately 1.78 mm for the entire reach, which is, indicative of a sand-bed stream. Since no active bank erosion was observed on site, the increase in accumulation of finer material from 2005 to 2007 may be attributed to increased stream flow. Approximately four bankfull events were documented from September 2005 to present by quarterly monitoring evaluations under the Army Corp of Engineers permit. The increased stream flow could have distributed the finer material on site.

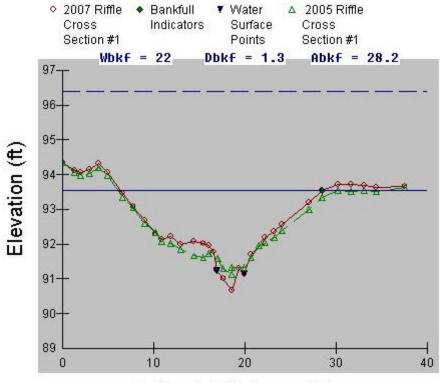
### Riffle Cross Section #1

Based on comparisons of Year 2005 to Year 2007 monitoring data, both cross sections appear stable with little or no active bank erosion. Graphs of the cross sections are presented in Appendix A. Future survey data will vary depending on actual location of rod placement and alignment, however, this information should remain similar in appearance.
